Re: Certain customer meter set configurations where the service regulator is situated directly above and in close proximity to the meter casing.

ADVISORY BULLETIN #: EGPS080501

Subject: Potential safety hazards associated with certain residential meter set configurations.

PIPELINE SAFETY ADVISORY BULLETIN

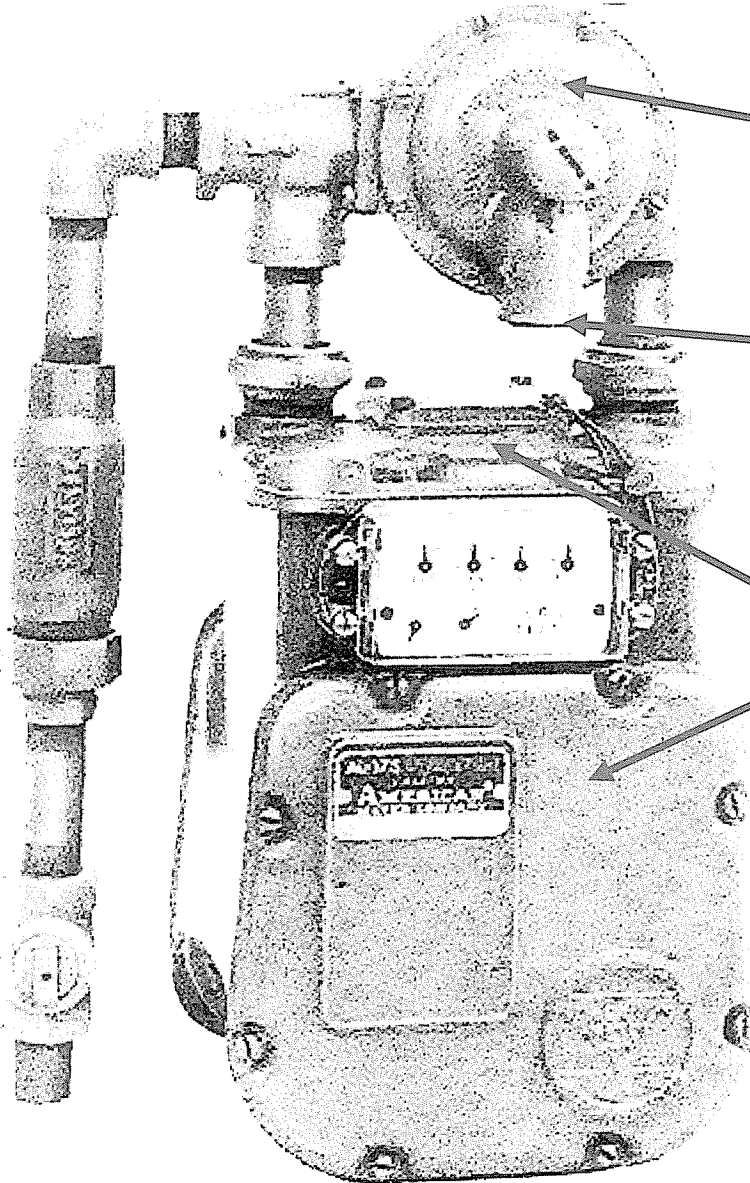
The Pipeline Safety Staff has recently been made aware that it is possible many Operators in South Carolina have residential meter sets configured in such a manner that the service regulator vents face downward just above the meter casing. (Please see attached for example.) The close proximity of the vents with the casing, coupled with them being installed below a roofline where the regulator vent may catch rainwater runoff poses a potential icing problem when temperatures fall below freezing. The freezing of the regulator vent generally results in a loss of gas flow to the customer. However, in some instances the regulator may become fixed in an open position, allowing gas to continue to flow when demand reduces, resulting in overpressure of the customer piping. This cumulates in the possibility of fire, and/or explosion in the customer's home.

Service regulator
installed directly
above the meter case.

Vent of the regulator
pointed at the meter
case, with very little
clearance and
susceptible to
accumulation of water.

Meter case.

It is recommended that each Operator identify the location any of these herein described meter set configurations in use on their systems and be prepared to take appropriate action as may be deemed necessary. Actions could include but not be limited to reconfiguring these sets, relocating them, or installing "splash guards" in the regulator vents.
